# Manhole Inspection Summary

Manhole # S37GG1009MH

Insp Date: **1/10/07 10:20 AM**

**Location** Address: **3937 GREENMOUNT AVE**

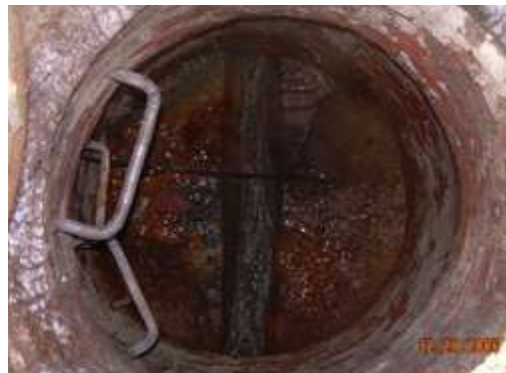
Top View

Bench debris

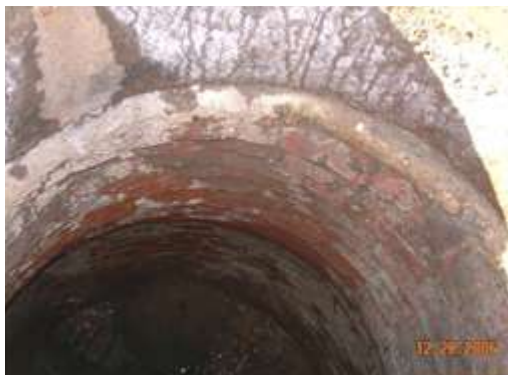
Defect

Frame leaks. Adjustment deterioration and infiltration. Barrel infiltration.

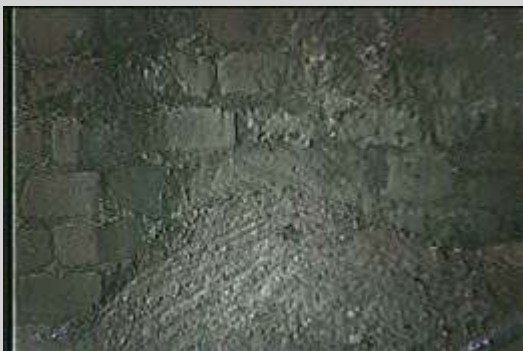
### 8 in. Circular Gravity Sewer Pipe In @ 3 O'Clock

Barrel deterioration and infiltration.

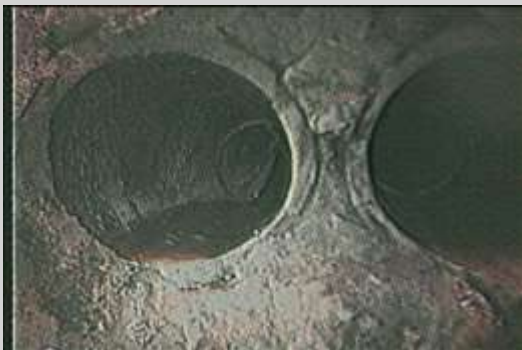
### 6 in. Circular Gravity Sewer

Infiltration: **Evidence** Pipe Seal Cond: **Unknown**

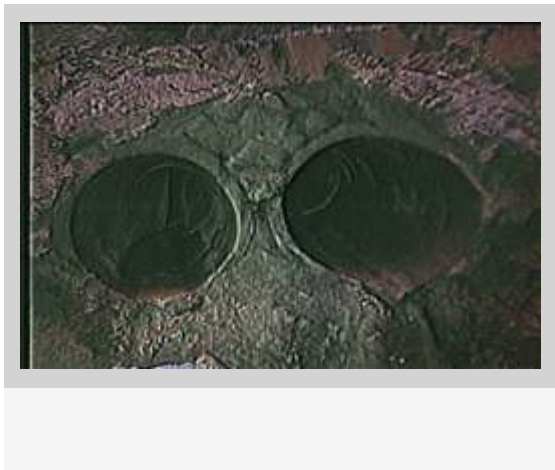
6 in. Circular Gravity Sewer  
Pipe In @ 10 O'Clock

Infiltration: **Evidence** Pipe Seal Cond: **Cracked**
